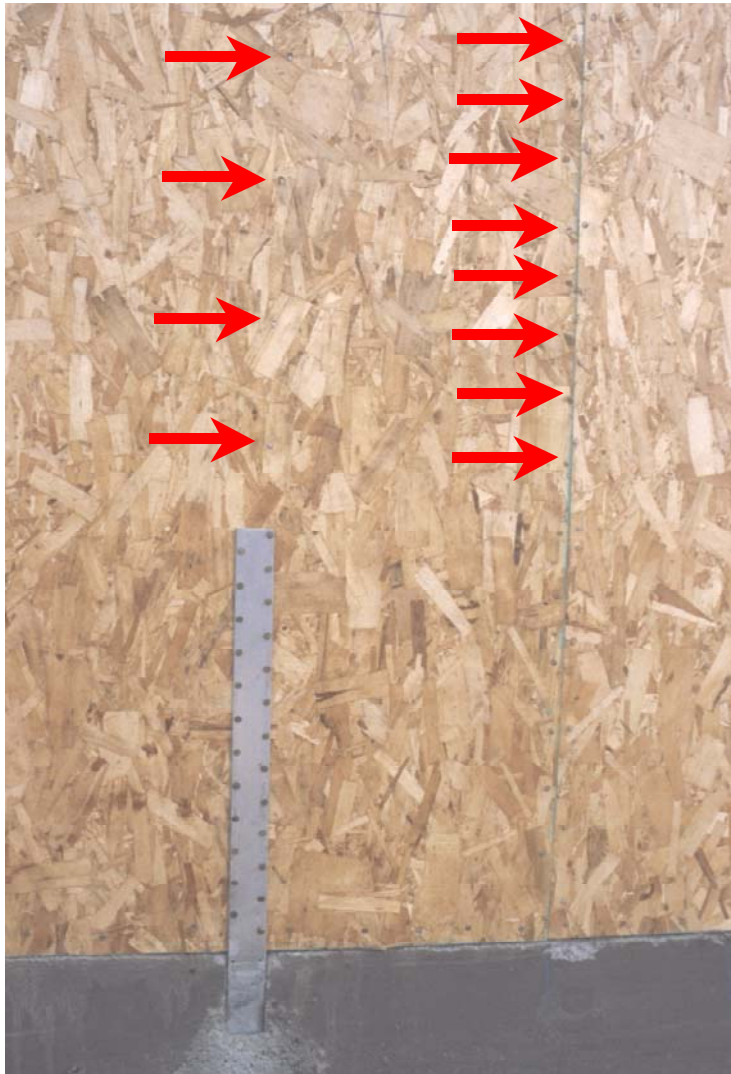
**Figure 60** This strap tie-down was bent after the concrete was poured, which spalled the concrete and did not enhance the strap's capacity. The arrows highlight panel nailing. Nailing to the post behind the strap tie-down should match the panel edge nailing, but only about half the required nails are present.
