Chapter 12 Other Earthquake Hazards

12.1 Masonry chimneys are killers

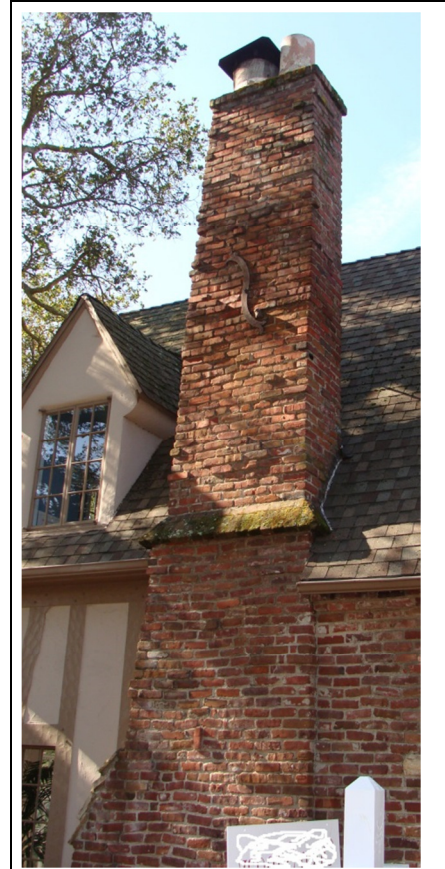
Figure 12-1 Many people look at a chimney and think “home.” Engineers and home inspectors think “danger.” Seismologists think “earthquake sensor.”

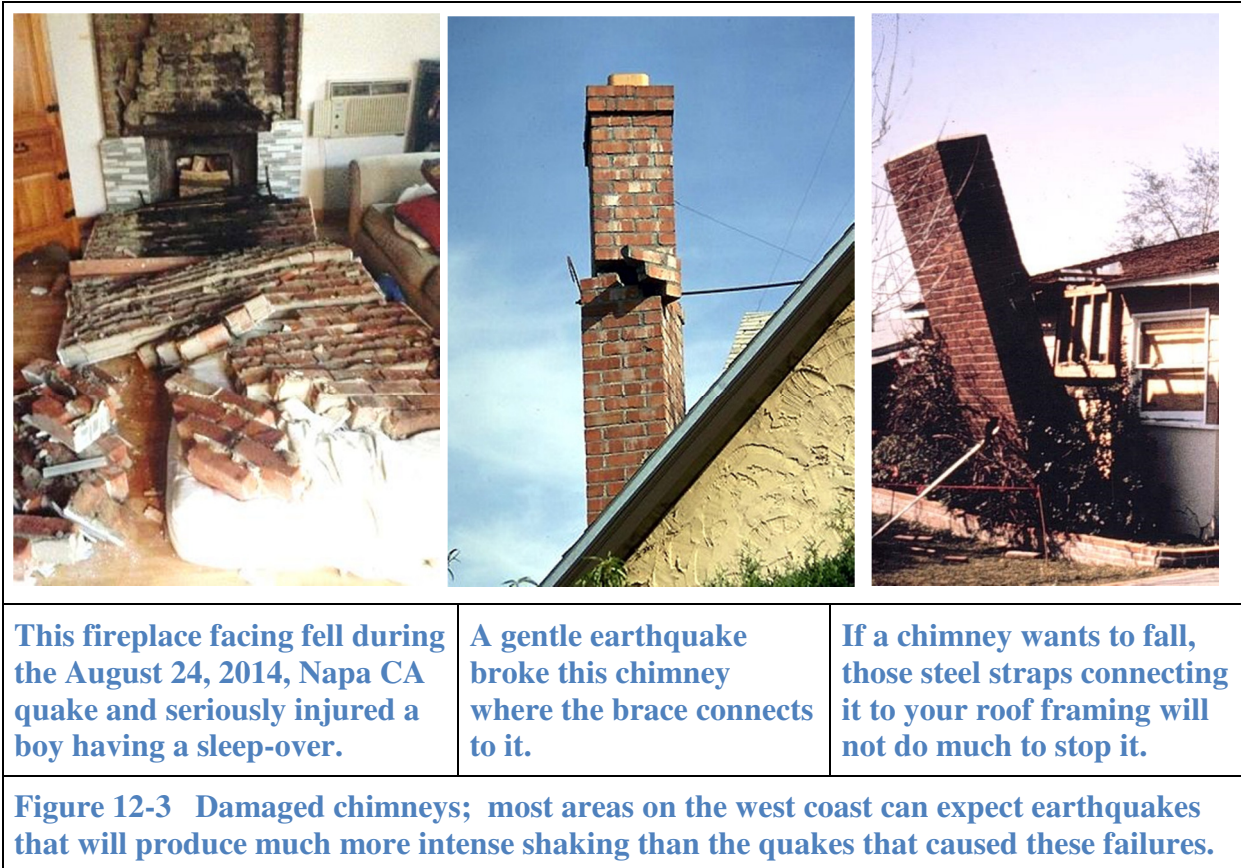
Figure 12-3 shows chimney damage caused by various earthquakes. After the Napa earthquake of 2014 I will recommend chimney removal even more strongly. When replacing roofs, some roofing contractors would rather remove your chimney down to the roofline at no charge than worry about waterproofing the joint between the brick and the roofing.

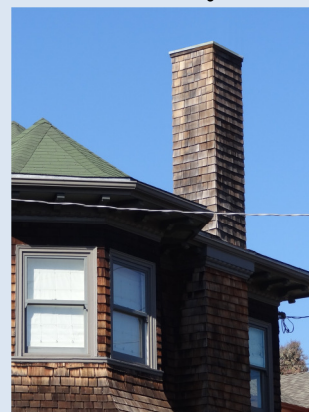
As I was taking photos of this very tasteful replacement of a Berkeley chimney, a curious neighbor struck up a conversation. When I explained myself, he excitedly told me how many chimneys had fallen or suffered serious damage in the Loma Prieta earthquake, which was centered 60 miles away. The Hayward Fault will shake about 20 times harder when it breaks loose, toppling many chimneys that are now older and weaker.

Wood-framed replacement “chimney”

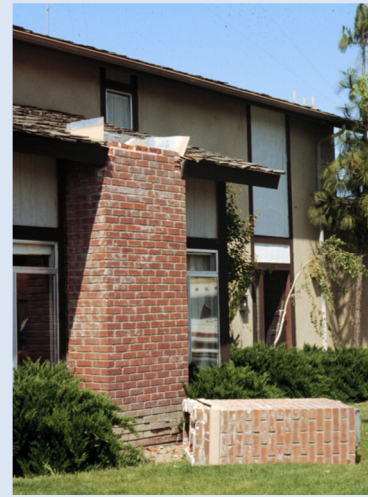
The photo below shows one of many “modern” chimney failures. FEMA photo

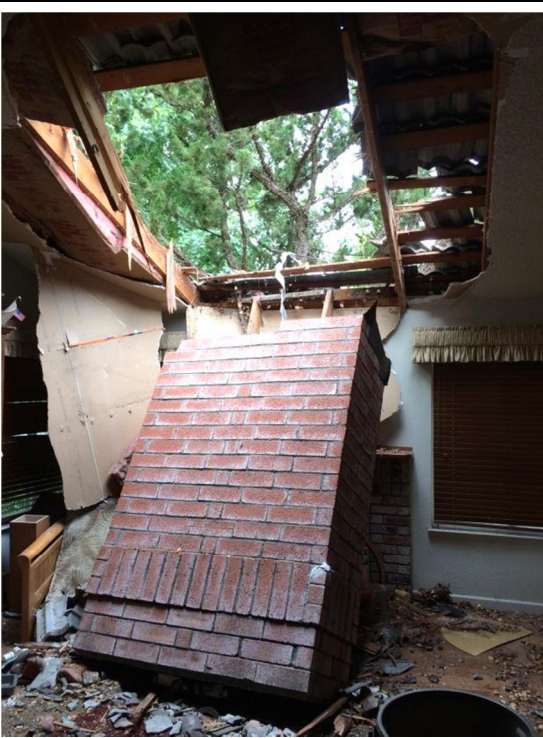
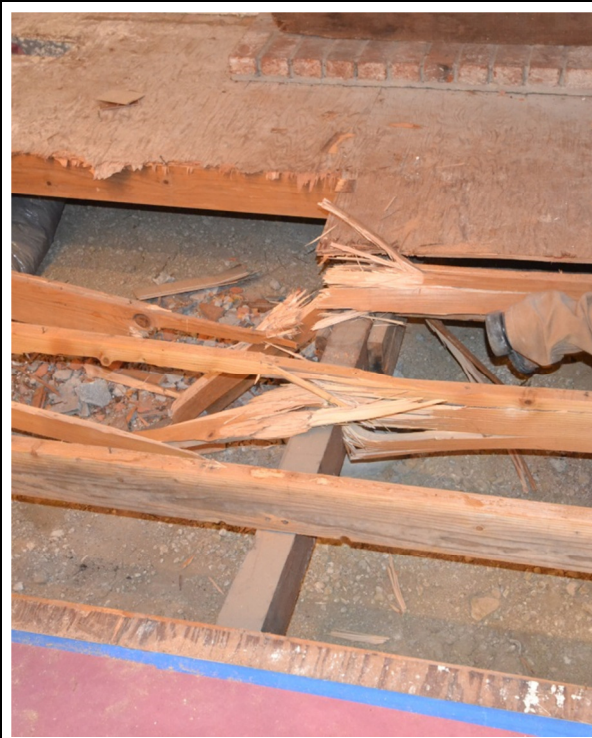
Figure 12-4 Left: A chimney toppled by the 2014 Napa, CA earthquake. This chimney was built around 1980, over 30 years after codes began requiring steel reinforcing in chimneys. By then an entire generation of masons should have known about the “new” code requirements for this basic and essential reinforcing; how much do you trust *your* chimney?

Right: Floor framing crushed by the chimney where it landed.
