## Appendix F

### Severe Roof Weakness Present in some pre-1920 Houses

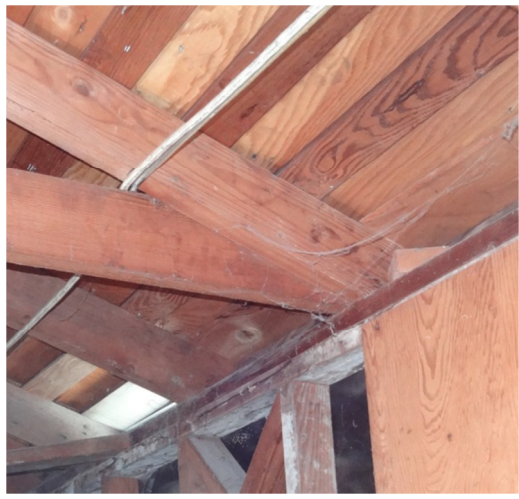
<p><b>Figure 1 GOOD: Typical roof rafter connection to wall and ceiling joist used in contemporary construction. The ceiling joist ties rafters on opposite sides of the house together so the walls do not spread apart. The “face-nailed” connection from the joist to the rafter is the most secure type of nailed connection.</b></p>

Most roofs overhang the walls of the house. An interior view of the most common framing method for constructing the overhanging portion of the roof is shown in Figure 1 and Figure 2. The rafter is cut to fit onto the top plate of the wall, and extends beyond the support to create the eave overhang. Ceiling joists span across to the rafters on the opposite side of the house and tie pairs of rafters together so they do not collapse and push the walls apart. Some sort of tie across the house is essential to keep this type of roof standing. A detailed discussion of roof framing is outside the scope of this book beyond saying that the rafter ties (usually joists) should be as close to the bottom of the rafters as possible. “Collar ties” near the peak of the roof may be needed to resist the roof opening at its peak due to wind uplift, but they do not resist the outward thrust at the base of the rafters.

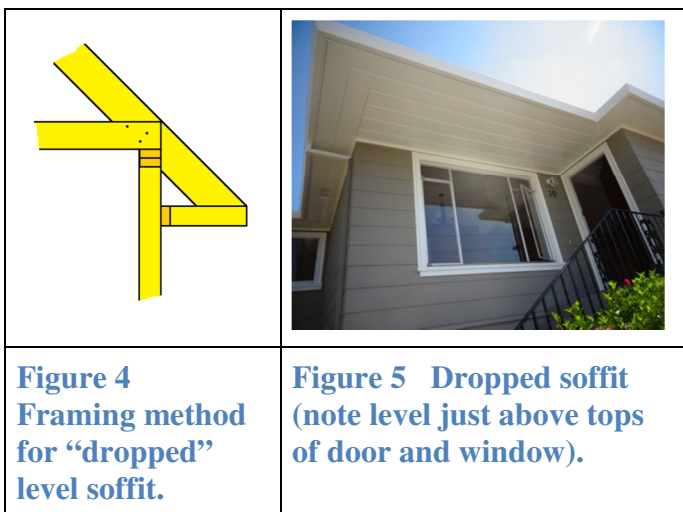
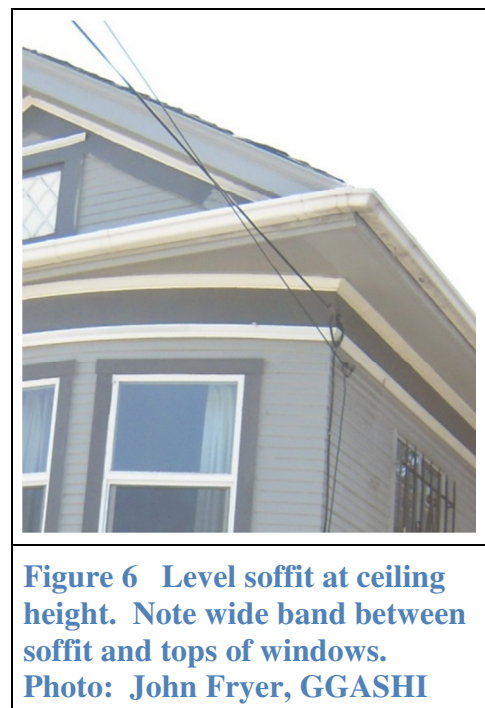
This particular weakness is created when a level soffit overhangs the walls. However, a level soffit does not always indicate the weak connection. Figure 4 and Figure 5 show a secure rafter connection with a level soffit. The key difference is the soffit is dropped below the adjacent ceiling height.

Figure 6 shows an early 20<sup>th</sup> century house with a level soffit at the ceiling height. Compare the distance from the soffit to the tops of the windows for the houses in Figure 5 and Figure 6.
